## *Out of Service Tie-Downs*

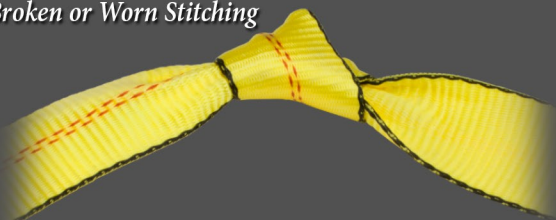
*Broken or Worn Stitching*
